# Manhole Inspection Summary

Manhole # S11YY\_005MH

Insp Date: **8/18/08 9:21 AM**

**Location** Address: **3536 WHITE CHAPEL RD** Cross Street: **BARRINGTON RD**

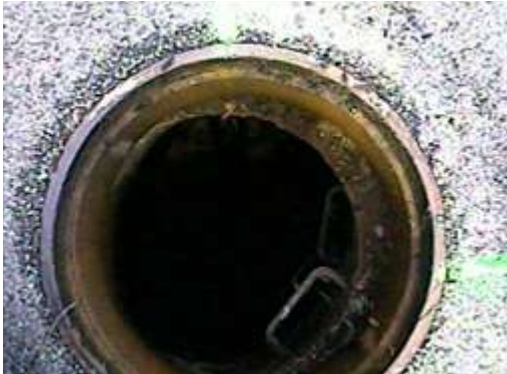
Top View

**Frame** Offset: **3** (in.) Condition: ☒ Sound ☐ Cracked ☐ Leaks

FRAME OFFSET

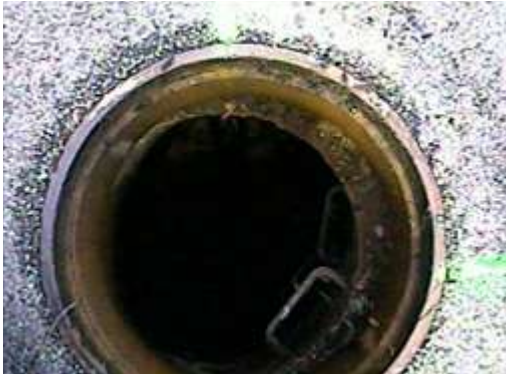
Defect 1

Condition: ☐ Sound ☒ **Cracked** ☐ Root Intrusion ☒ **Loose Brick** ☐ Deteriorated

LOOSE BRICK/CRACK ADJUSTMENT

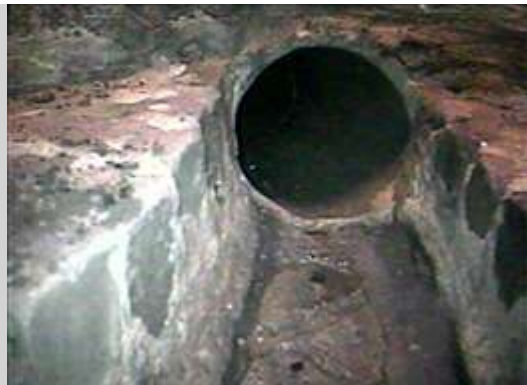
5 O'Clock Inflow

DEBRIS IN CHANNEL

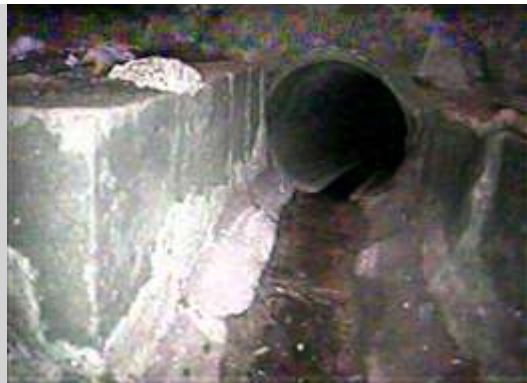
7 O'Clock Inflow

DEBRIS ON BENCH
